**NCTD'S PROPOSED "SAFETY" FENCING ON
DEL MAR'S ERODING BLUFFS INCREASES
CATASTROPHIC RISK
TO
TRAIN PASSENGERS, TRANSIT WORKERS,
BEACHGOERS & LOSSAN CORRIDOR**

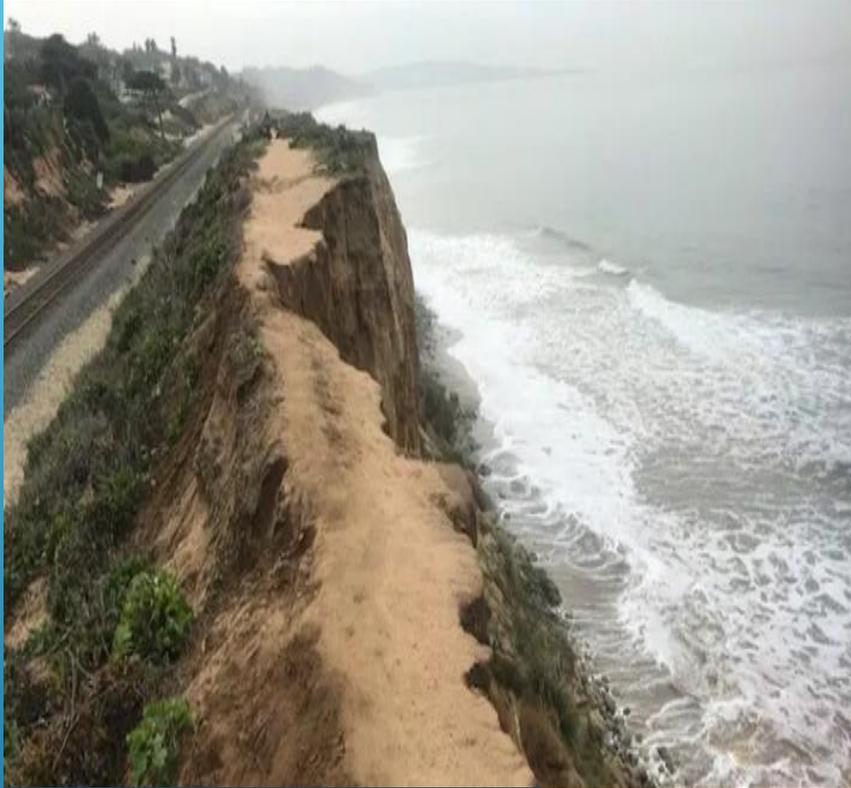
Photo: City of Del Mar Dec 2018

FENCING DESTABILIZES ERODING BLUFF

- NCTD proposes two 1.5 mile fences (each side of train tracks) on eroding sandstone bluff in Del Mar
- Drills 1,500+ post holes (3 ft deep every 10 ft) into fragile sandstone
- Fractures sandstone and adds stress of 633,600 lbs from cement footings + 6 ft high chain link fencing
- Creates 1,500+ new avenues for water intrusion
- Destabilizes eroding bluff and rail line near active offshore Rose Canyon Fault
- CA Earthquake Authority expects landslides from forecasted 6.5-6.8 Rose Canyon earthquake
- NCTD's 2-page geotechnical report contains too many holes to support this damaging project

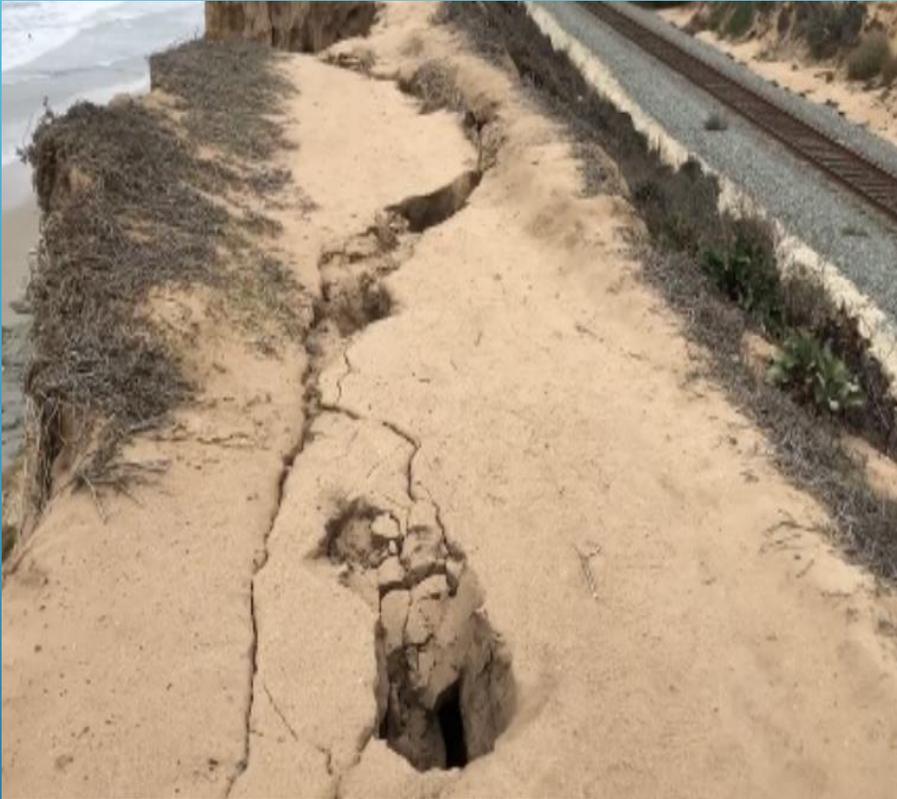
Photo: KUSI Newsroom July 21, 2021

INCREASES CORROSIVE WATER INTRUSION

- Sandstone geologically fragile and crumbles when saturated with water (see fissures in photo)
- SANDAG's \$100M project limits water intrusion
- NCTD's \$3M fence project dramatically increases water intrusion by over 10x
- Creates 1,500+ new channels for water to collect and flow through bluffs from fractures created by 3 ft deep post holes (2 drilled every 10 ft along tracks on the bluff)
- Destabilizes bluff and increases frequency of dangerous bluff slides

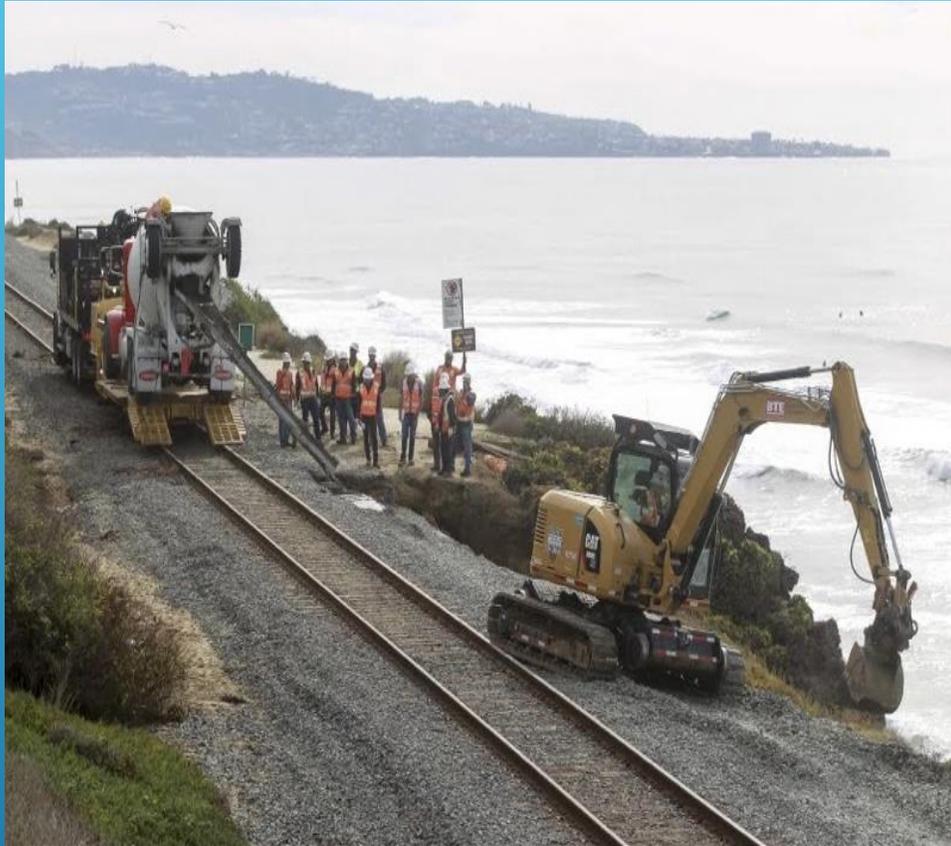
Photo: The San Diego Union-Tribune Nov 30, 2019

SHRINKS TRAIN RIGHT OF WAY (ROW)

- Surface runoff and subsurface water penetrate both sides of bluff
- Dirt from erosion on upper east bluff clogs drains, water overflows tracks, undermines track bed, and causes west bluff failure
- NCTD fencing adds 317 tons to bluff edges already weakened by water intrusion, erosion, vibration, and weight from 50+ trains/day
 - Commuter train: 1,500-6,000 tons
 - Freight train: 3,000-18,000 tons
- Fencing < 25 ft from tracks restricts ability to make future track and bluff repairs
- Violates 25 ft minimum clearance for NCTD Roadway Worker Protection Program

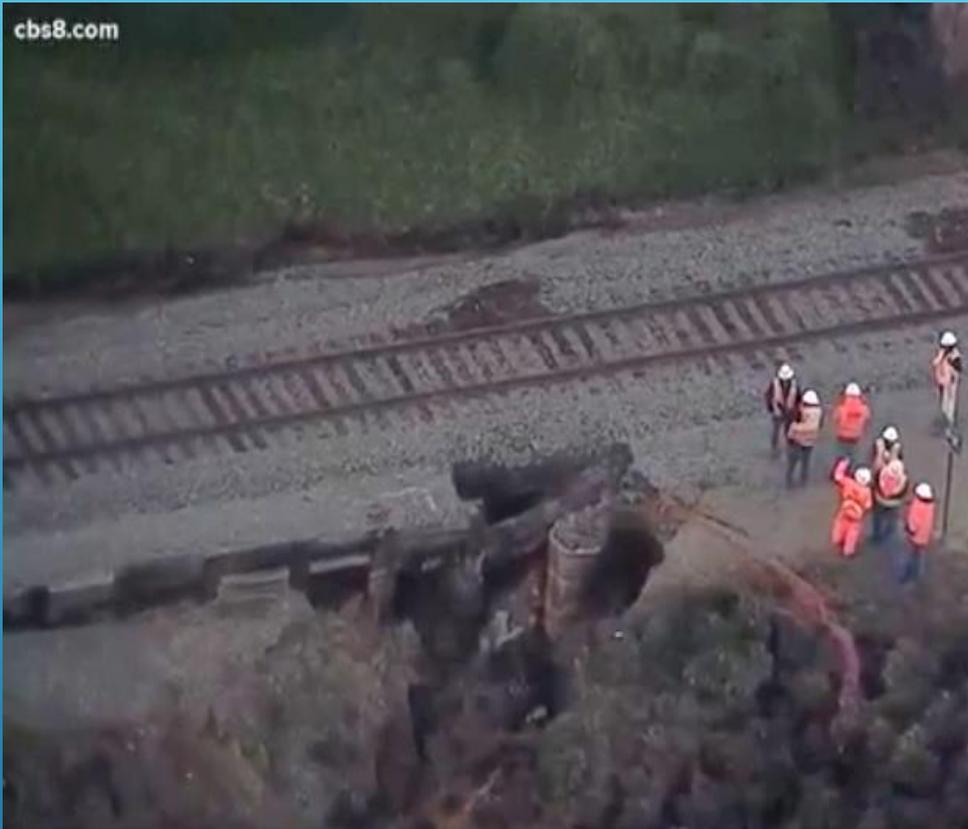
Photo: CBS8 Newsroom with Dr. Pat Abbott Nov 30, 2019

GEOLOGY PROFESSOR PAT ABBOT POINTS OUT DAMAGING EFFECTS OF EROSION

- Rainwater and ground water cuts through sandstone
- Erodes support around soldier piles and under retaining walls
- Retaining wall fails; bluff collapses only 2 ft from track
- Train service suspended for 2 days for emergency repairs
- Notes bluff slides increasing in size and frequency
- Climate change brings heavier rains and winds
- Large waves and storms eroding bluff toe
- Sea level rise exacerbating wave erosion

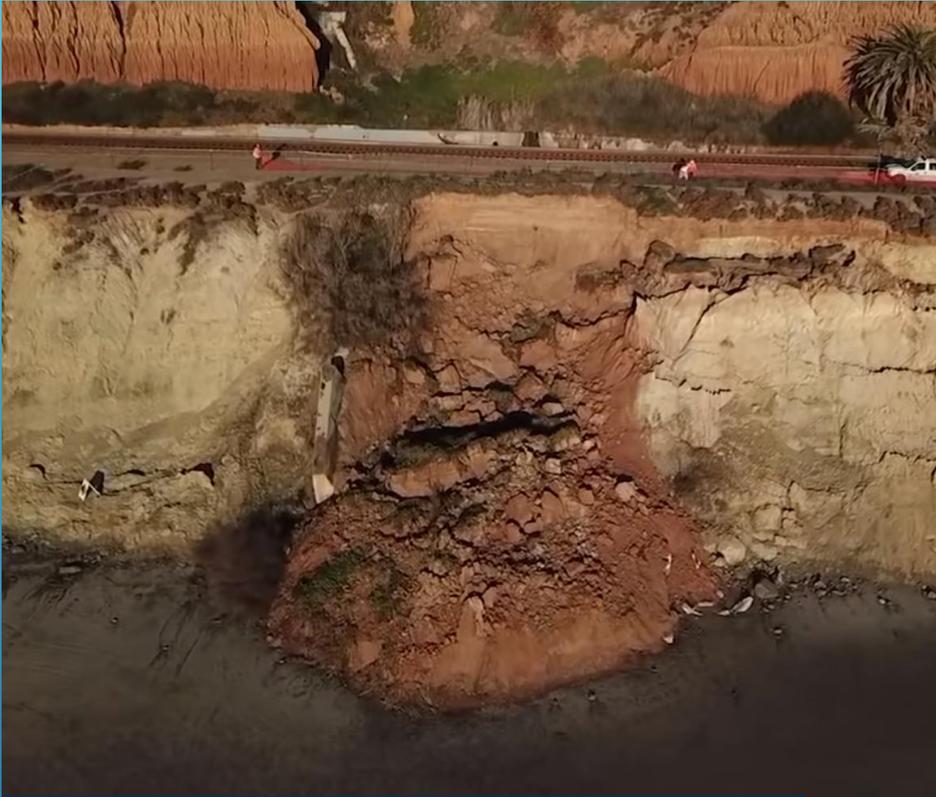
Photo: Fox 5 San Diego Drone Video Feb 28, 2021

MORE BLUFF SLIDES AFTER HEAVY RAINS

- Rainwater and groundwater seeps deep into bluffs
- Wet sandstone is heavier and erosion makes it more prone to failure
- Note slide area's damp, dark, and wet loose sandstone
- 50 ft wide section of the bluff fell on Del Mar beach below
- Fortunately, search and rescue found no one buried under tons of sandstone
